# **Lahar Initiation and Sediment Yield in the Pasig-Potrero River Basin, Mount Pinatubo, Philippines**

A thesis

**Doctor of Philosophy in Engineering Geology**

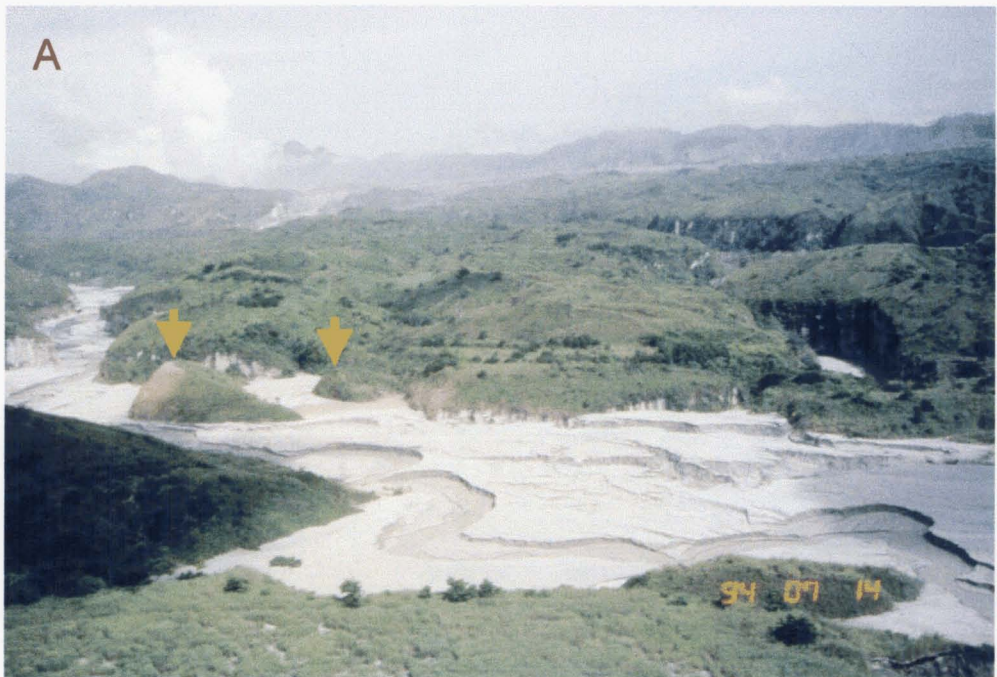
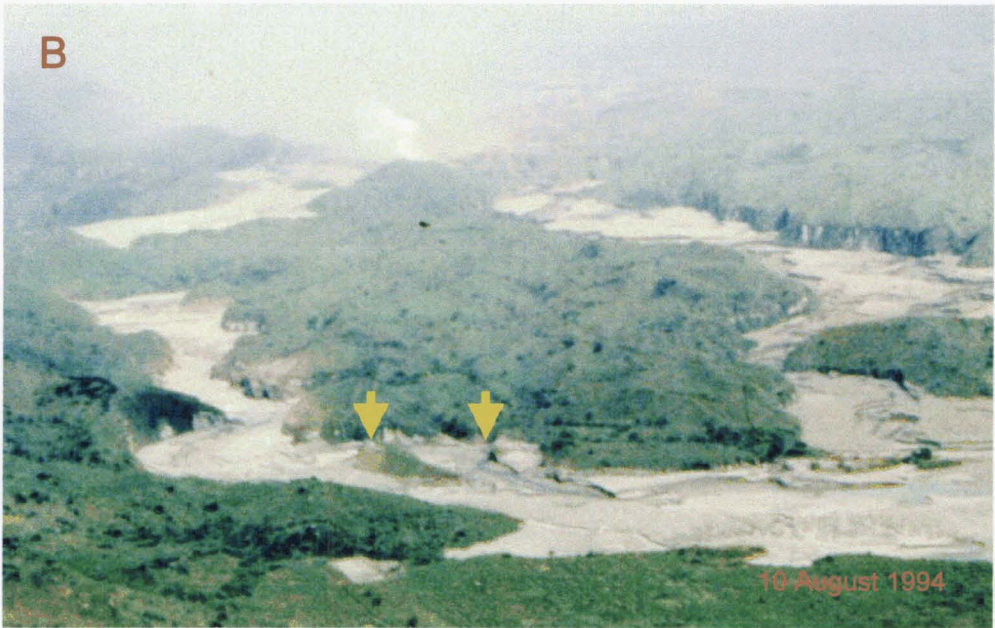
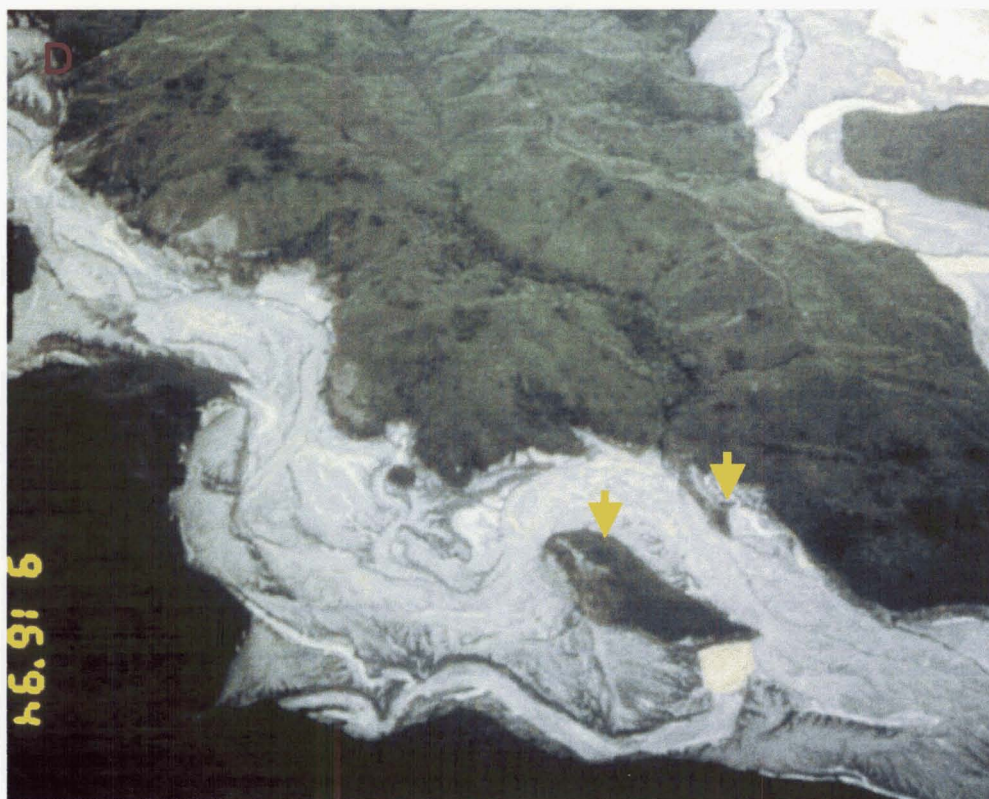
Figure 2.6. Bed-level changes in the Papatac Creek channel, from 14 July to 16 September 1994, in area near the Papatac-Timbu confluence, 2-3 km downstream of the Cutuno blockage. Aggradation in the Papatac is noted between 14 July (A) and 10 August (B), as indicated by the level of submergence of two reference hills (marked by arrows) in the Papatac channel. No significant deposition is noted after 10 August (B, C and D), suggesting that the Bucbuc Creek had been completely diverted into the Timbu, thus effectively beheading the Papatac, by 10 August. (Photos A, B and C courtesy of C.G. Newhall; photo D courtesy of PHIVOLCS)

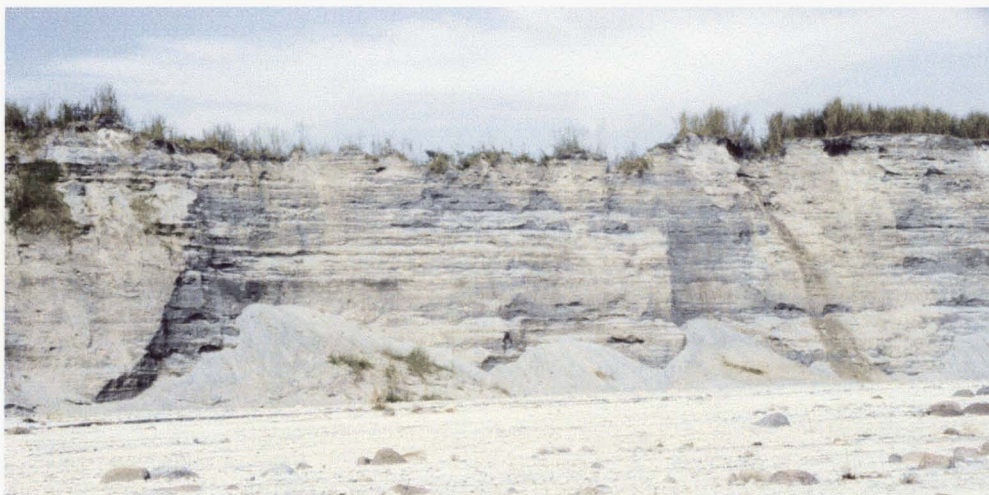
Figure 3.1. Uppermost stratigraphic sequence of the pre-1991 Pasig-Potrero alluvial fan; photo taken near the apex of the fan at Delta 5. This >15-m sequence consists of stratified, loose, sandy layers characteristic of normal streamflow deposits. Debris-flow units are conspicuously absent in this sequence.

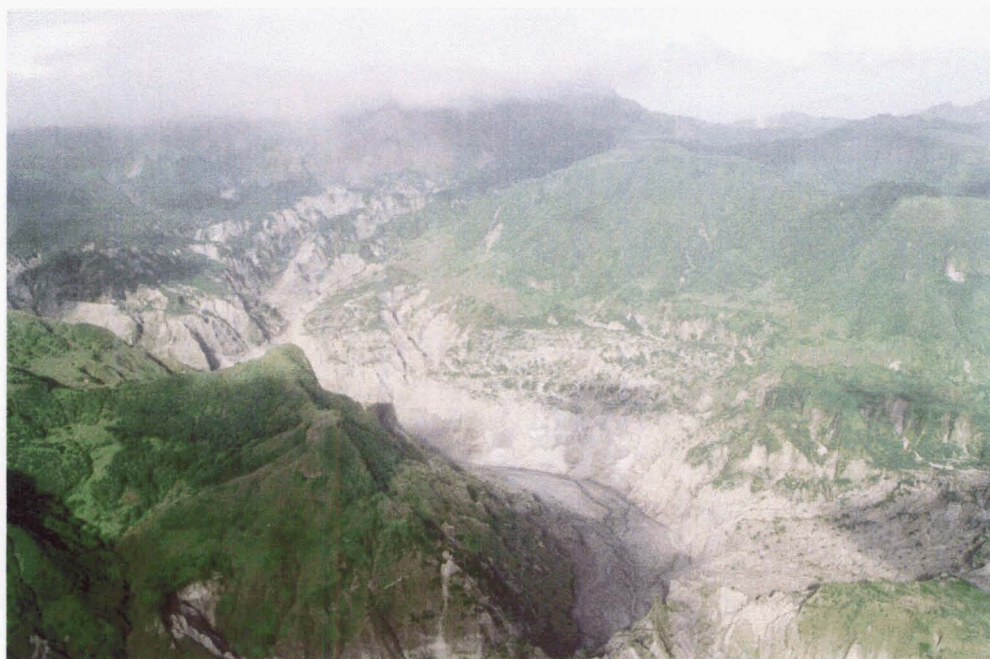
Figure 3.10. 1999 photo of the upper Pasig (formerly Sacobia) catchment showing depleted, partly vegetated pyroclastic-flow deposits, large channels incised in pre-eruption deposits, and thickly vegetated hillslopes. View is upstream; Pinatubo is in the center background partly hidden by clouds.

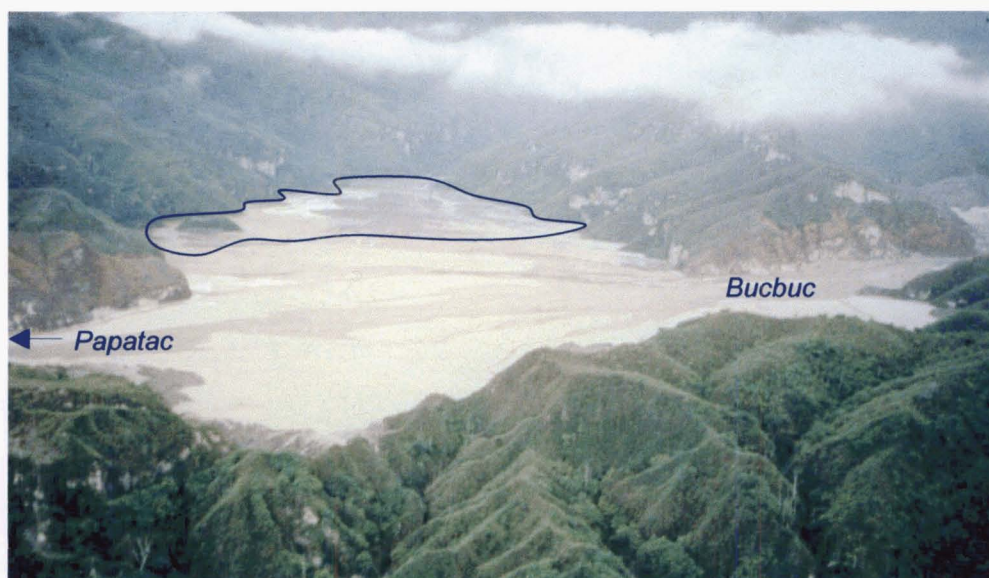
Figure 5.4. Incipient formation of Cutuno Lake on 05 July 1994, photo looking southwest, up the Yangca valley. The eventual lake is approximated by the blue outline. The light-colored dam deposit in the Bucbuc-Papatac valley (middle of photo; flow from right to left) was mainly from a secondary pyroclastic flow that occurred in late June. The deposit from this event buried the divide between the Bucbuc and the Timbu (on the other side of the hills in the foreground), just upstream (to the right) of the area shown in the photo. The burial of the divide caused subsequent flows from the upper Bucbuc to be gradually diverted to the Timbu, thus abandoning this dam site. *Photo reprinted with permission from Punongbayan et al. (1996).*

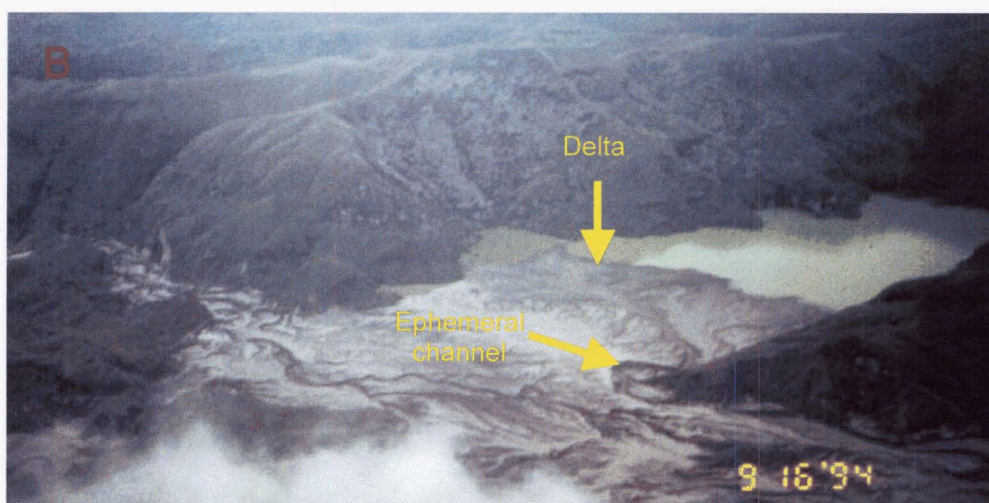
*Photo courtesy of PHIVOLCS*

Figure 5.7. Cutuno Lake at its full extent on 30 August (A) and 16 September (B) 1994; the crest of the dam is marked by the dashed line in A. A natural spillway had formed at the distal end of the blockage (lower left in A). The ephemeral channel (lower right in B) partially draining the Papatac Gap formed a fan-shaped delta prograding into the lake.

The lake was being drained by a natural spillway of unknown dimensions located on the distal end of the fan-shaped blockage, against the bedrock on the east side of the Yangca valley (Figure 5.6A, Figure 5.7A). The ephemeral channel noted in the preceding paragraph and in Figure 5.5, was forming a prograding delta into the lake, continuously supplying the dam with pumiceous sediment, albeit at a greatly reduced rate. These conditions were maintained until the last observation on 16 September, a week before the lake catastrophically drained.

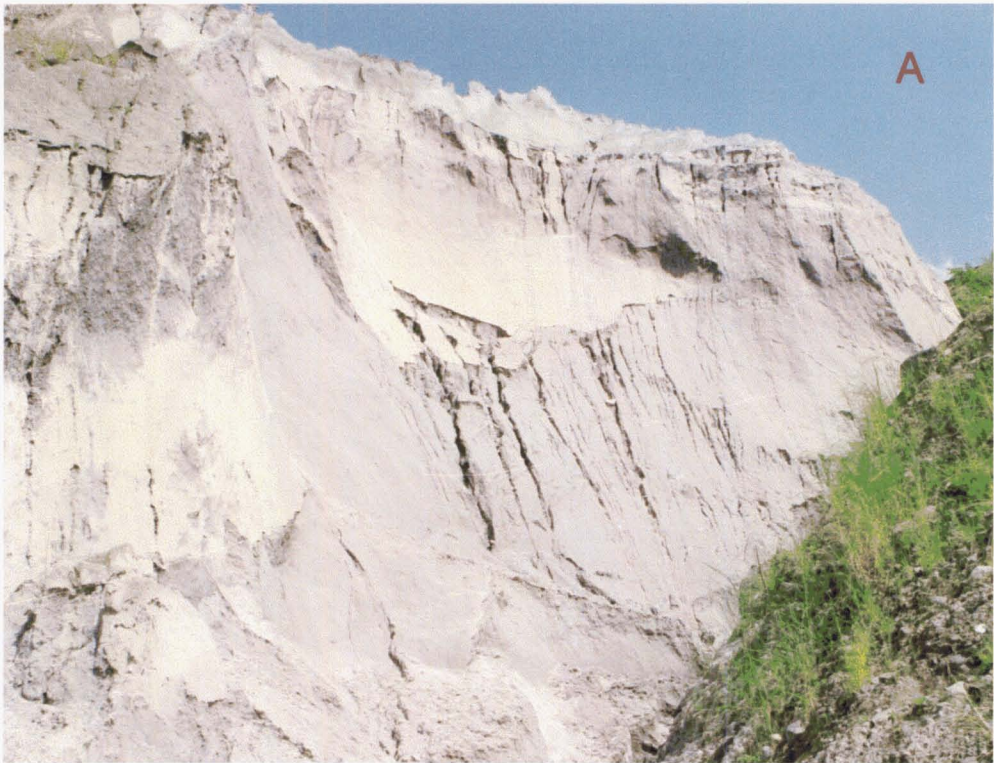
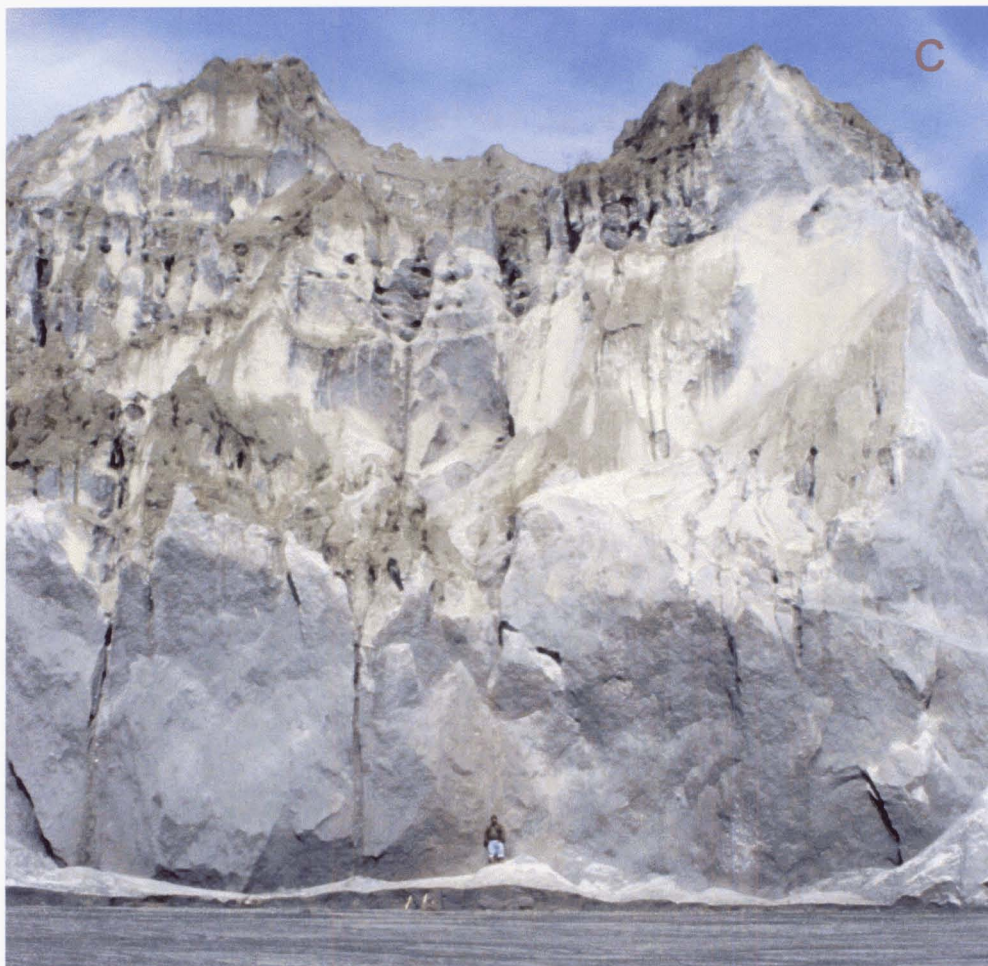
Figure 5.8. Sections of the secondary pyroclastic-flow deposit which dammed Cutuno Lake. The deposit has a characteristic pinkish coloration (A) and, in portions, features abundant gas-escape structures (B). Exposed sections are up to 40 m thick, are massive, and often have steep faces (C). Hot water was seeping out at the base of the deposit when this photo was taken in November 1999.

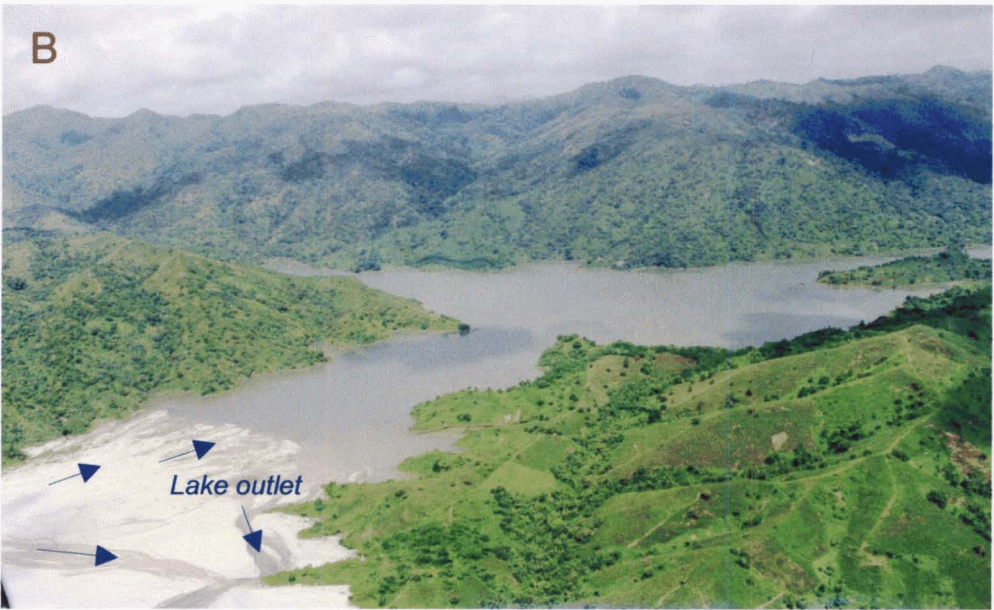
Crow Valley Lake, July 1999 (Photo courtesy of PHIVOLCS)

Figure 5.14. West-looking photos of the Crow Valley Lake, which was formed by rapidly aggrading lahar deposits from the O'Donnell River (flow direction indicated by thick arrow in A) that have fanned out into the drowned valley. The photos show net aggradation between 1994 and 1999, indicating continuous supply of sediments to the dam by sediment-laden streamflows (small arrows). A small debris fan had formed where a small tributary joins the outlet channel on the downstream (north) side of the dam. The outlet channel has more or less maintained its width and depth from 1994 to 1999.

Under Settings 2 and 3, transient dams are continuously fed by sediments by the blocking channel through lahars or through sediment-laden flows along many small fan distributaries. Figure 5.14, for example, shows how flow along the O'Donnell River has delivered sediments to the Crow Valley Lake blockage, in effect continuously building up the dam. The flow rate along the O'Donnell varies from  $\sim 10 \text{ m}^3/\text{s}$  distributed among small fan-distributaries, to several hundred  $\text{m}^3/\text{s}$  transported by floods or lahars during rainstorms. At Cutuno, sediment is delivered to the outlet channel largely by rills that have formed on the blockage surface (*Please see* Figure 5.7, *Section 5.3.2*). The ephemeral channel that discharges mostly into the lake may also have occasionally delivered sediment into the outlet channel.

(Figure 5.14) suggests that fan-flow sedimentation may more than compensate for erosion along the dam spillway.

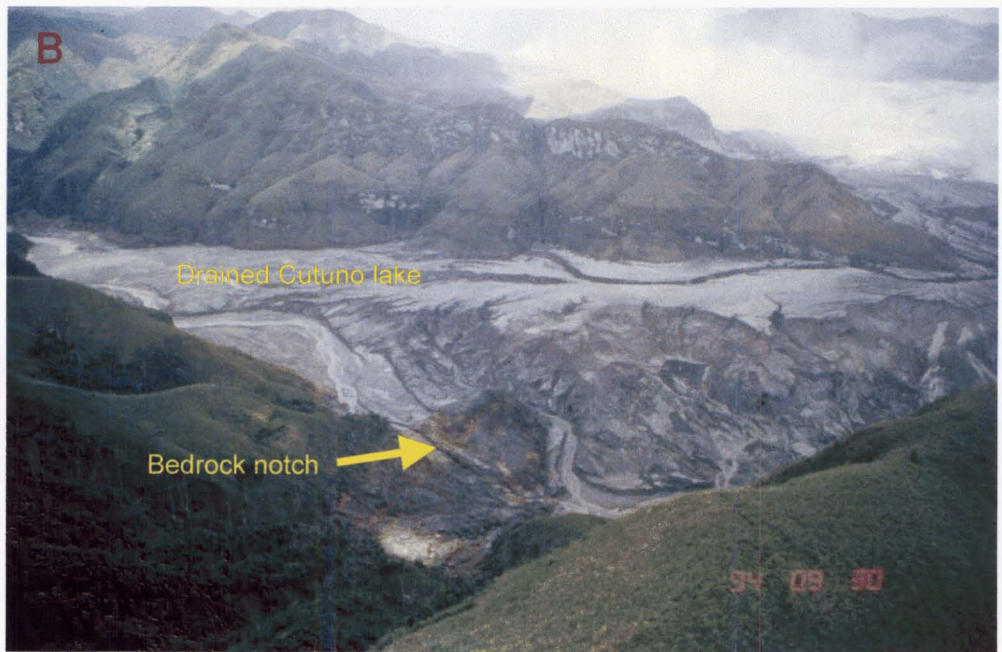
Drained Cutuno Lake, 30 September 1994, look similar to A (northwest). The Yangca Creek flows towards the right of the photo. (Photo courtesy of C.G. Newhall)

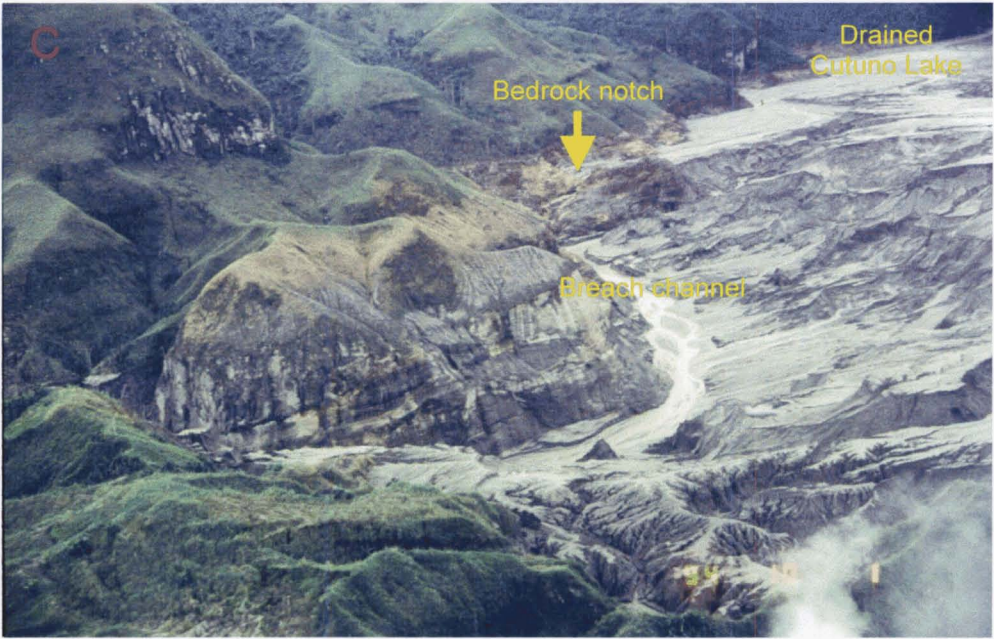
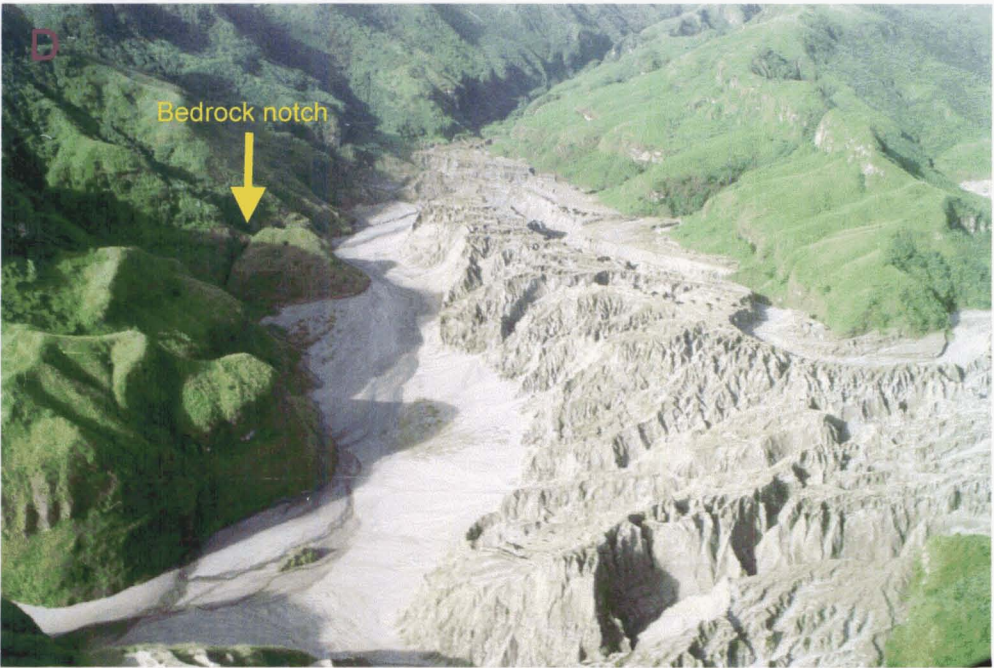
Drained Cutuno Lake, 01 October 1994, looking up the Yangca Creek (southwest).  
(Photo courtesy of R.S. Punongbayan)

Former Cutuno Lake, November 1999, similar view direction as in C.

Figure 5.17. Evolution of the dam breach channel after the 22-23 September 1994 Cutuno lake breakout; both photos looking up the Yangca. The breach channel that initially passed through a notch in a bedrock ridge (A) had shifted around the ridge by 30 September (B and C), where the channel has remained until 1999 (D). The channel further incised by 20 - 30 m, which suggests it was still in the process of adjusting when it was observed on 23 September. This indicates that the lake-breakout probably occurred shortly before that observation.

Further evidence that suggests that the lake-breakout indeed occurred on 22-23 September was the observation that the breach channel had apparently not yet reached a stable level when it was observed on 23 September. As shown in Figure 5.17A (also in Figure 5.16B), the breach channel (the Yangca Creek) initially passed through a notch in a bedrock ridge, which was at an elevation 380-390 m asl on 23 September. This was the same bedrock notch through which Cutuno Lake drained in 1992 (Arboleda and Martinez, 1996, p. 1051-1052). Subsequent aerial observations on 30 September showed a further lowering and lateral shifting of the breach channel (Figure 5.17B and 5.17C). Instead of passing through the bedrock notch, the breach channel was now going around the ridge, at an estimated elevation of 360 m asl, 20-30 m lower than on 23 September (Figure 5.17C). The Yangca channel has maintained this alignment and elevation until 1999 (Figure 5.17D).

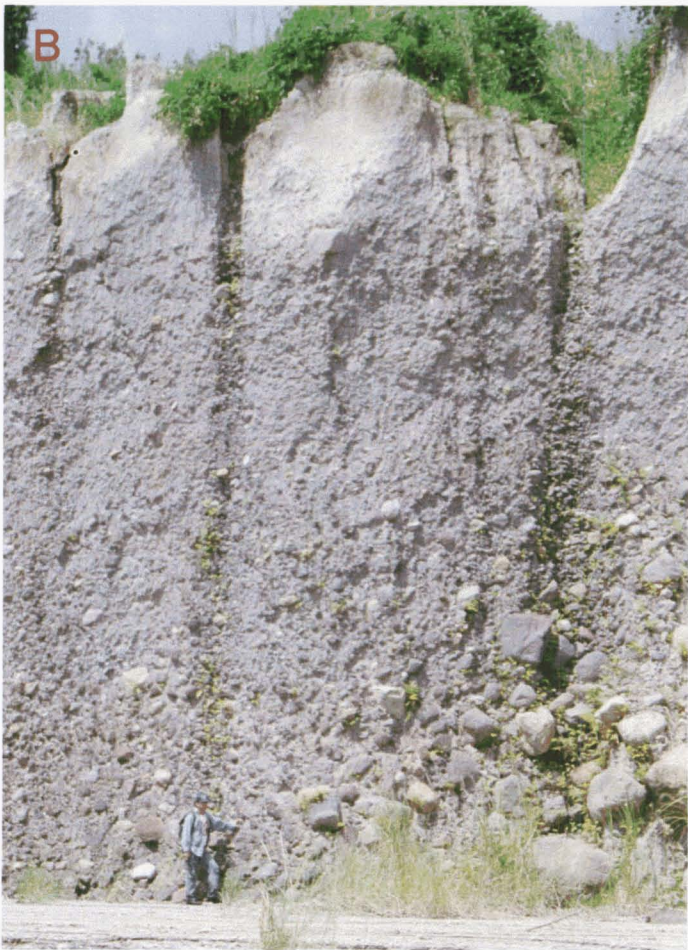
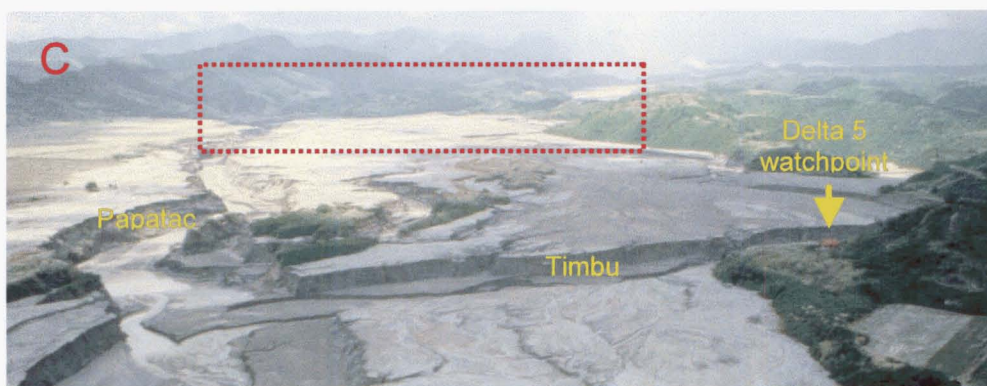
*Photo taken on 30 September 1994, courtesy of C.G. Newhall*

Figure 5.19. Impacts of the 1994 Cutuno lake-breakout lahars on the Pasig-Potrero alluvial fan. The 22-23 September lahars deposited thick, bouldery sediments up to the level of the pre-eruption terraces just upstream of Delta 5, before incising a new Papatac channel through the right-bank terrace (A). Photo B shows the lithic-rich bouldery deposits in section. The lake-breakout lahars probably combined with simultaneous lahars along the Timbu channel to carve a deep canyon near Delta 5, which funneled the flows to the lower alluvial fan (C). The area covered by A is approximated by the dotted rectangle in C.

The 22-23 September lahars re-exhumed the Pasig channel downstream of Delta 5 and dumped the remobilized deposits in the lower alluvial fan, burying several barangays of Porac and Bacolor, and killing more than 20 people. These lahars initially deposited thick deposits near Delta 5 that almost buried the pre-eruption terraces in the area (Figure 5.19A). Succeeding lahars on the 24-25 September, however, caused great channel erosion from the Papatac gorge down past Delta 5 (Figure 5.19B; *See also* Figure 5.18B), and remobilized the deposits farther downstream.
